MUNCIE

Unsafe Building Study

This project was completed by the Plan 632 Studio at Ball State University in conjunction with the City of Muncie Unsafe Building Hearing Authority. Students completed this project in two phases, in the first phase, ten graduate students performed fieldwork on all the structures currently being addressed by the City of Muncie Unsafe Building Hearing Authority. For the second phase, two students enrolled in an independent study class compiled the collected information and integrated it with other data into a Geographic Information System.

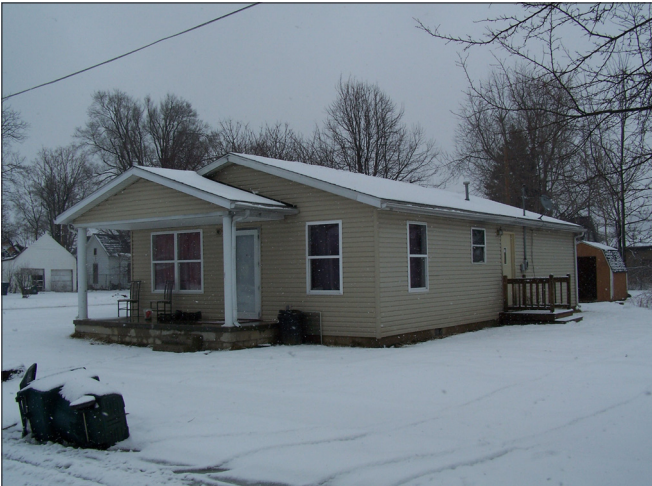
at 606 Wolfe, the home appeared to have recently underwent renovation, but electrical service was present. At the time of survey, winter conditions combined with apparent occupancy of the home indicated that it was most likely being heated internally by kerosene, a fire hazard and clear violation of city code.

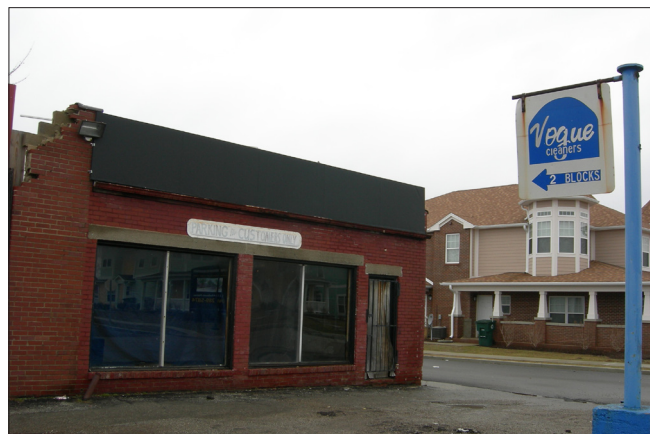
above, the relative neighborhood location of these structures were found to be in very favorable condition. As illustrated in the case of 1001 S. Madison Street as picture below, the structures are in severe disrepair. Millennium Place, Muncie's premier Hope VI Urban Renewal Project can be seen in the background. In this case, it is apparent that the commercial structure in question lost its viability before Millennium Place was built, during the time when that area was occupied by a crime-ridden housing project. Residents of neighborhoods that contain these structures are undoubtedly frustrated with their appearance and suffering from decreased property values due to these eyesores. Thanks to the overall quality of surrounding neighborhoods, sites like these can once again become economically viable and less of an eyesore.
