MUNCIE

Unsafe Building Study

This project was completed by the Plan 632 Studio at Ball State University in conjunction with the City of Muncie Unsafe Building Hearing Authority. Students completed this project in two phases, in the first phase, ten graduate students performed fieldwork on all the structures currently being addressed by the City of Muncie Unsafe Building Hearing Authority. For the second phase, two students enrolled in an independent study class compiled the collected information and integrated it with other data into a Geographic Information System.

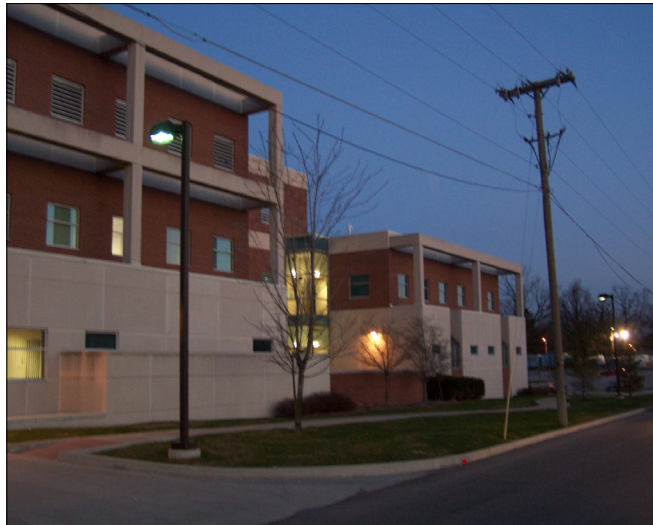
In all, previously rehabilitated structures represent a total of \$8,493,700 in 2005 tax value, an average of \$146,443.00. This large average can be attributed to the fact that five of the rehabilitated structures have been replaced by high value structures such as an auto parts store, Social Security Office, and medical complex as shown to the right.

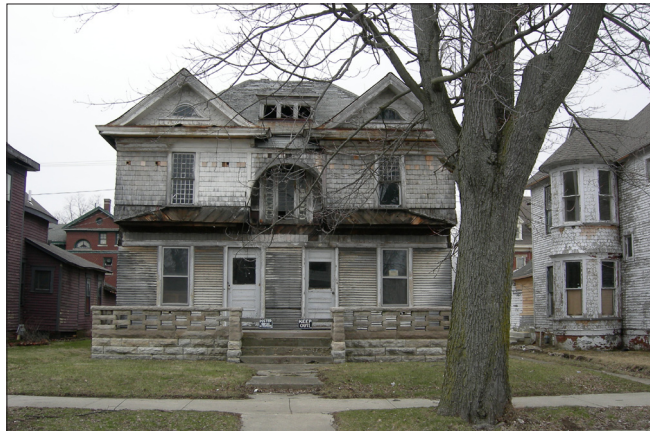
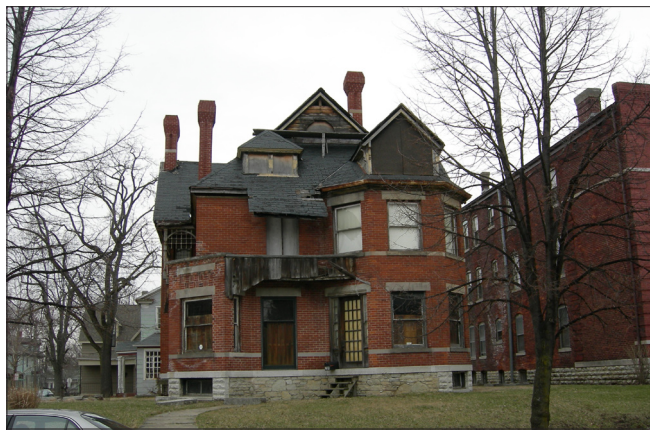
continue to fall farther into disrepair, these structures might be lost forever. One positive factor is that almost 80% of these structures were found to be within the 2-3 rating range.

This means that while these structures face serious problems, at this time, a majority appear salvageable. Significant efforts should be made on behalf of the city and local historic district organizations to return these structures to their grandeur. One source of rehabilitation funding for these structures would be through Federal Historic Preservation Grants and other aid provided by the National Trust for Historic Preservation.

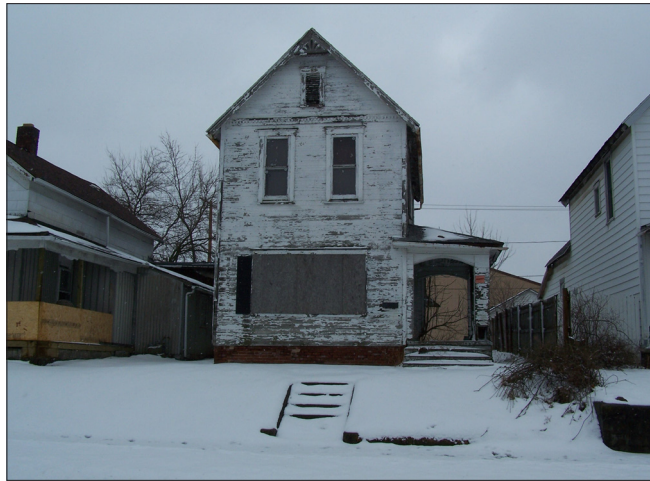
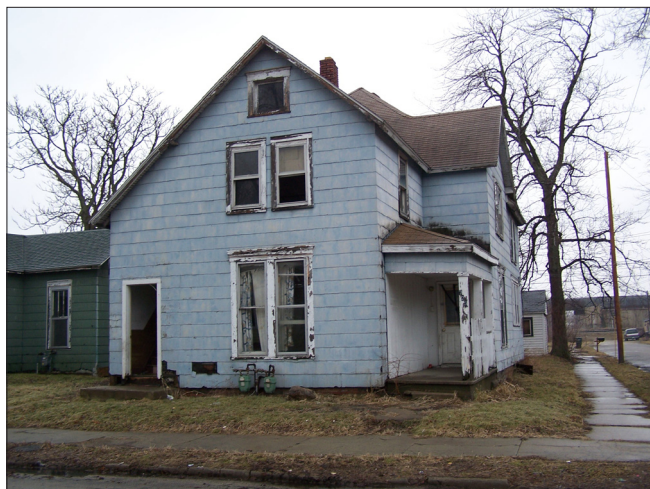
Of the structures recommended to be kept on the unsafe building list, the field survey team found 136 of them to be secured and 170 unsecured. Due to the winter weather conditions at the time of field survey, teams were easily able to notice violations of this nature as shown in the pictures below. The Unsafe Building Hearing Authority requires that all structures under their scrutiny be secured as is or through man-made measures. This includes the boarding of broken windows and kicked-in doors. These orders are mostly for public safety means and also reduce liability on behalf of the property owners.

With over 55% of the structures unsecured, a multitude of problems exist in terms of possible deviant activities. These activities pose a problem for the entire City of Muncie and its residents. With unsecured homes, the probability of attracting squatters rises. Opportunities for thieves to steal scrap metal from these structures also increased when they are not appropriately secured. Structures are also appealing to other criminals, some of which seek to conduct drug dealing within the confines of these structures.

Significant efforts should be made by property owners to secure these structures and deter this type of activity from happening. The City of Muncie and Unsafe Building Hearing Authority should also investigate these issues and pursue possible fines for to this type of violation. Although securing these structures with temporary means does not ensure they will not be entered illegally, it is a proactive approach to the problem.

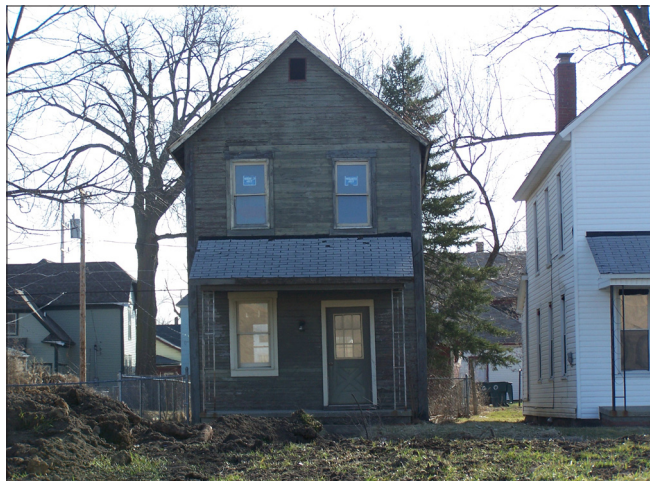
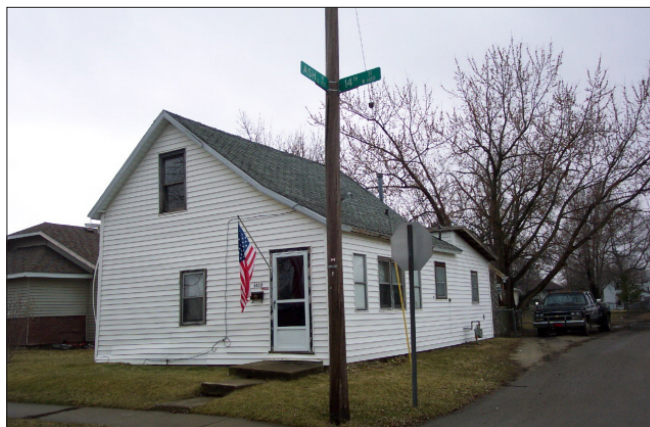
Of the 306 structures found to be unsafe, survey teams found 104 of them to be occupied, and 202 to be unoccupied. The weather conditions at the time of survey made it easy for the field survey teams to identify structures of this nature. Clear signs of structure heating, footprints in the snow, and resident activity allowed the teams to quickly document the status of these structures. As required by the Unsafe Building Hearing Authority, all structures are required to be unoccupied until property owners make necessary repairs before structures are deemed safe for human inhabitation.

While a majority or 66% of the structures were found to be unoccupied, nearly 34% were found to be occupied. This occupancy is a clear violation of Unsafe Building Hearing Authority orders and Delaware County Health Department recommendations. Many of these structures have severe structural defects and are not to be occupied for health and safety reasons. The status of a structures occupancy directly relates to its status as being secured. While in some cases structures appeared to be occupied by authorized residents or tenants, this occupancy status also applied to persons who inhabit structures illegally and conduct deviant activities in them.

Once again, significant efforts should be made by the City of Muncie to reinforce these orders through fines and possible eviction. Although these actions will undoubtedly be unpopular, they are in the best interest of the community as a whole. Efforts should also be made to assist people who are forced out of their homes, as they may not have any other means of shelter. This could be partially achieved through a referral service to local outreach organizations such as the Muncie Mission.
